# Manhole Inspection Summary

Manhole # S37E\_\_037MH

Insp Date: **1/23/09 12:21 PM**

**Location** Address: **234 holiday st**

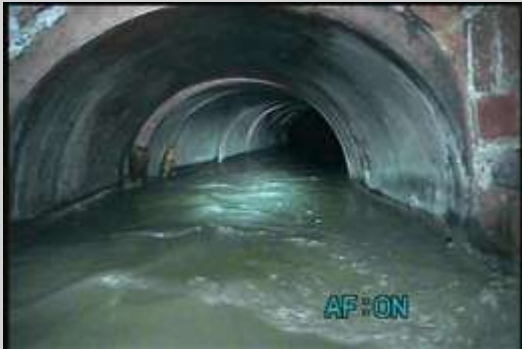
12 O'Clock Outflow

24 in. Circular Gravity Sewer  
Pipe Out @ 12 O'Clock

Pipe Material: **Clay** ☒ Pipe Lined

Infiltration: **None** Pipe Seal Cond: **Unknown**

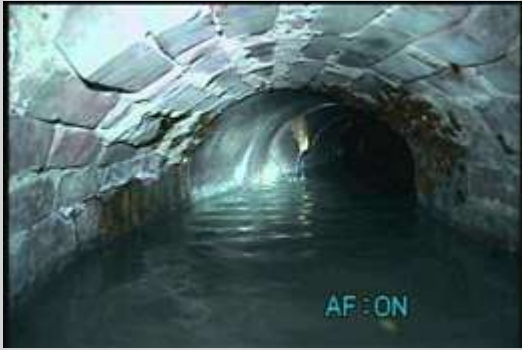
5 O'Clock Inflow

21 in. Circular Gravity Sewer  
Pipe In @ 5 O'Clock

Infiltration: **None** Pipe Seal Cond: **Unknown**

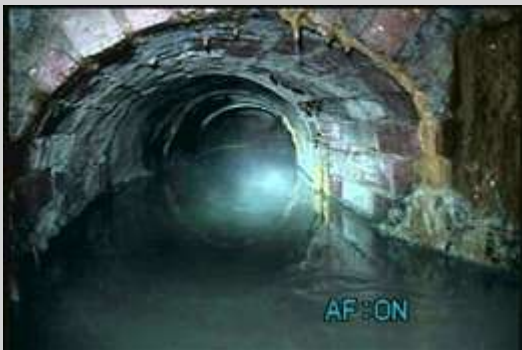
7 O'Clock Inflow

21 in. Circular Gravity Sewer  
Pipe In @ 7 O'Clock

Infiltration: **None** Pipe Seal Cond: **Unknown**
